January 10, 2025

STRUCTURAL INTEGRITY RESERVE STUDY REPORT

**THE ADMIRAL CONDOMINIUM
8750 S OCEAN DRIVE
JENSEN BEACH, FL 34957**

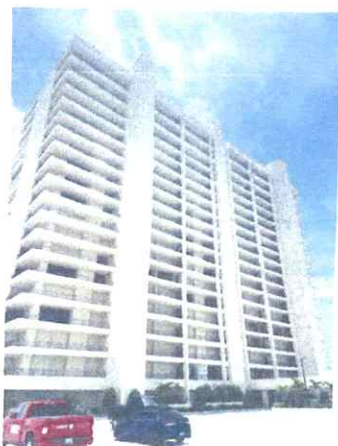
PHOTO 1

FRONT ELEVATION OF BUILDING

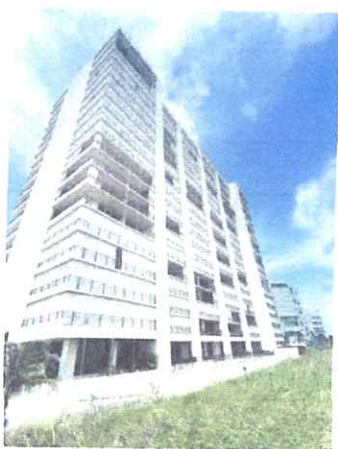
PHOTO 2

REAR ELEVATION OF BUILDING

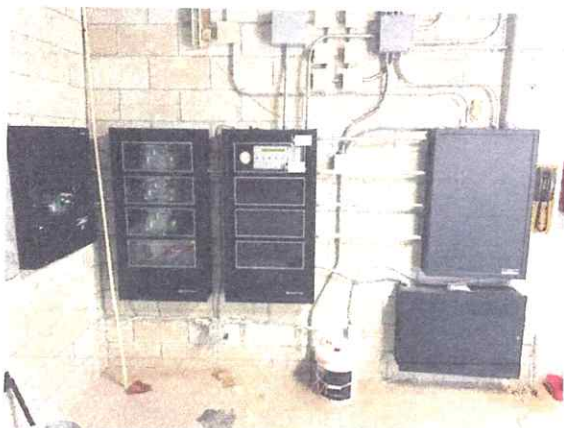
PHOTO 3

FIRE SAFETY SYSTEM MAIN PANELS

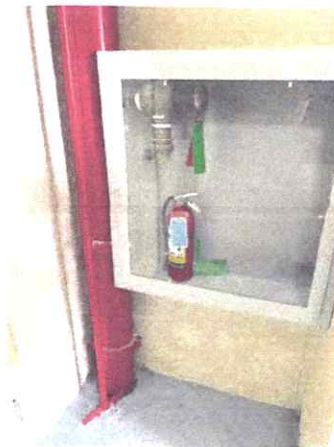
PHOTO 5

FIRE EXTINGUISHER AND STANDPIPE

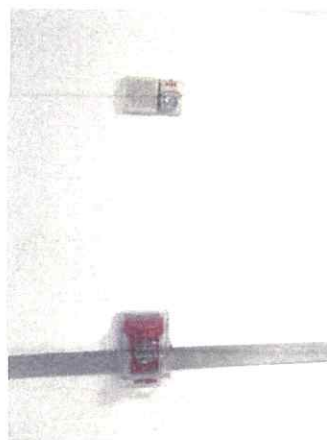
PHOTO 6

FIRE SAFETY SYSTEM EMERGENCY DEVICES

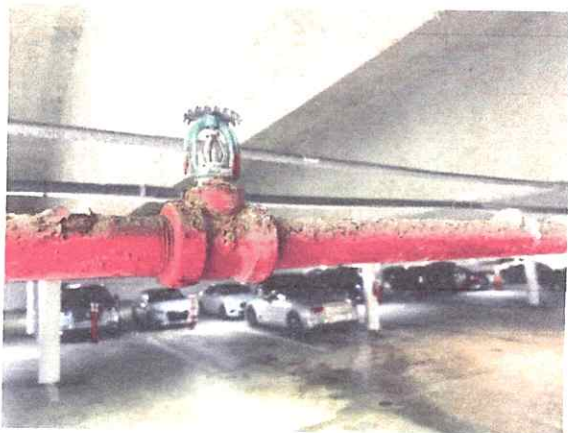
PHOTO 7

FIRE SUPPRESSION PIPE IN GARAGE WITH RUST

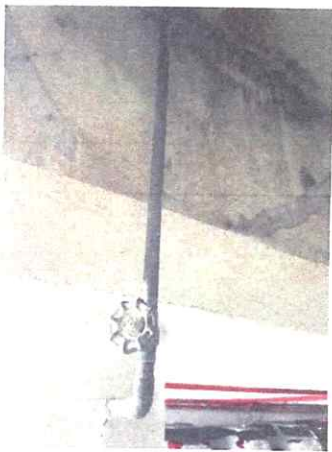
PHOTO 8

COPPER WATER PLUMBING PIPE IN GARAGE

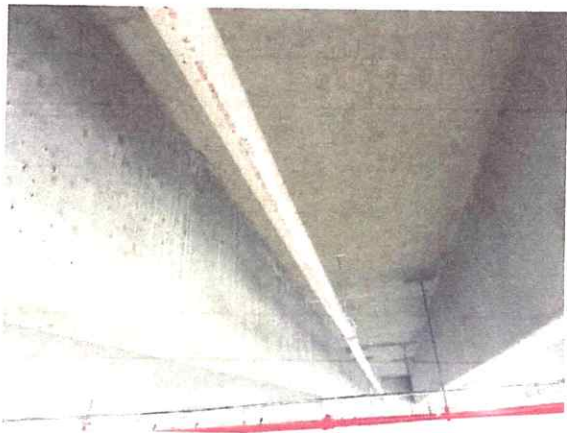
PHOTO 9

REPLACED PVC PLUMBING PIPE IN GARAGE

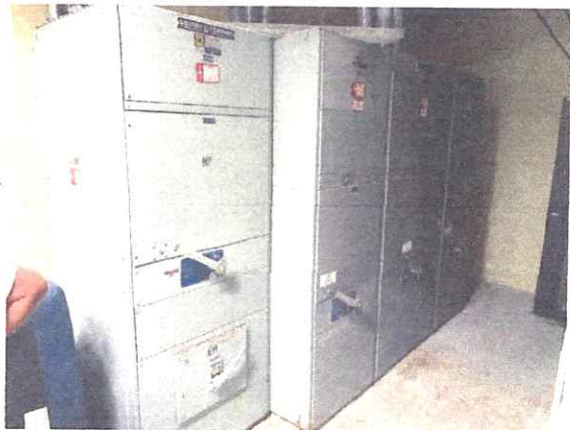
PHOTO 10

MAIN ELECTRICAL PANELS

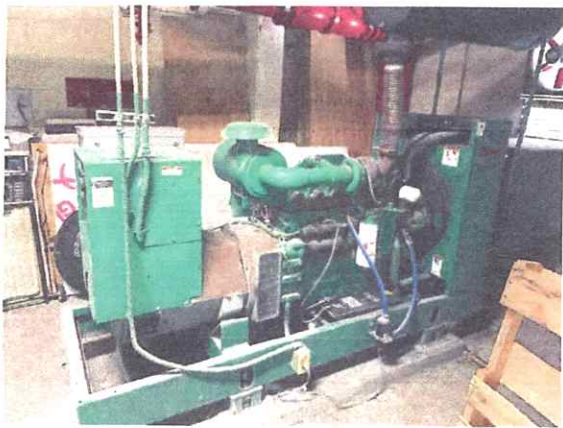
PHOTO 11

EMERGENCY GENERATOR
